**EVALUATION OF SSME HIGH PRESSURE  
LIQUID OXYGEN TURBOPUMP BEARINGS**

**GEORGE C. MARSHALL SPACE FLIGHT CENTER  
MARSHALL SPACE FLIGHT CENTER, ALABAMA**

**April 6, 1979**

**BATTELLE  
Columbus Laboratories  
505 King Avenue  
Columbus, Ohio 43201**

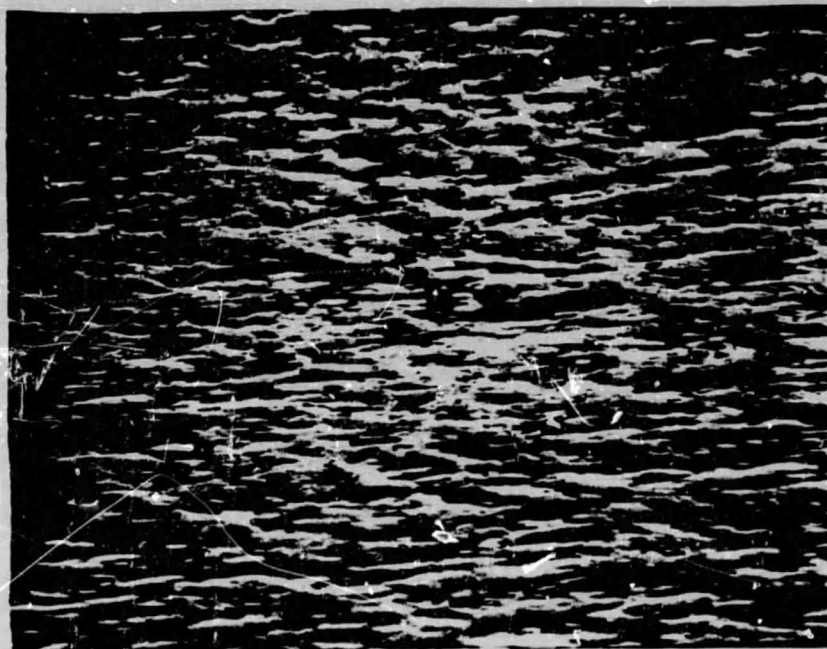
FIGURE 1. SCANNING ELECTRON MICROGRAPHS OF  
DAMAGE TO INNER RACE OF BEARING  
8517903

The inner race of bearing 8517903 showed evidence of considerable distress when examined at low magnifications. Three distinct continuous bands were present, which resulted from contact with the balls. Extending from the chamfer on the largest inner race diameter was a smoothly worn band approximately 2.97 mm (0.117 inch) wide. Its color was grey to brown in patches, which probably was a combination of oxide layers and transferred TFE from the retainer. By placing a ball from the bearing in this portion of the race, the use of transmitted light showed that the wear (and possibly deformation) was sufficient to change the race curvature to match that of the ball. Extending away from the smoothly worn band was a 2.08 mm (0.082 inch)-wide band consisting of numerous fine pits. Finally, a third polished narrow band 0.69 mm (0.027 inch) wide completed the ball contact track. Since the bands did not vary significantly in width or location, apparently the synchronous radial loads were not high compared to the axial loads in service.

Scanning electron microscopy (SEM) was used to examine the details of the race wear. Typical areas are presented in Figure 1. In Figure 1(a), the larger pits appear to be shallow fatigue spalls that progressed from right to left in the micrograph. The wear features shown in Figure 1(b) were aligned with the direction of rolling. The surface consisted of a series of furrows, which were probably caused by mild adhesive wear with the balls, and scattered fine pits.

(a) Pitted Band Area

(b) Worn Band Area

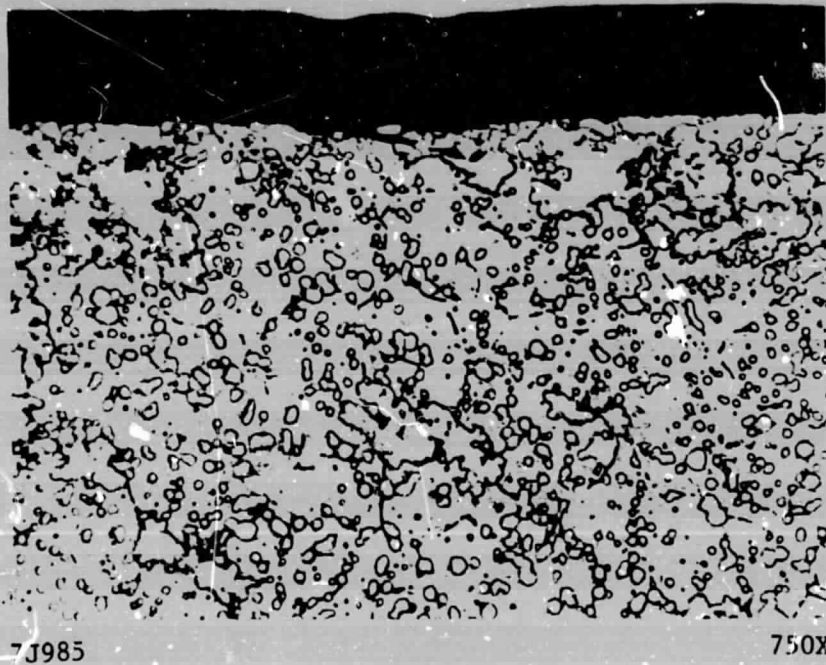
FIGURE 2. MICROGRAPH SHOWING CROSS SECTION OF  
SURFACE SPALL AND CRACK PROPAGATING  
FROM THE SPALL ON INNER RACE OF  
BEARING 8517903

Metallographic sections were prepared across the inner race to measure the depth of the spalls, to determine whether any fatigue cracks extended into the bulk material, and to measure the microhardness as an indication of maximum operating temperature. A micrograph of a section through one spall is presented in Figure 2. The spalled region was approximately 2  $\mu$ m (80 micro-inches) deep. The micrograph also shows that a crack had progressed into the surface and to the right from the bottom of the spall. The crack progressed along the carbide-matrix interface or through the carbides themselves. This

spall probably would have tripled in width and reached a depth of 6.3  $\mu\text{m}$  (250 microinches) in a short time of additional running. Microhardness readings taken on the metallographic section just under the worn surfaces could detect no reduction in hardness from the bulk hardness. Since 440 C stainless steel requires a tempering temperature of 204 C (400 F) to begin to reduce hardness, temperatures of this level were not attained by this inner race in service.

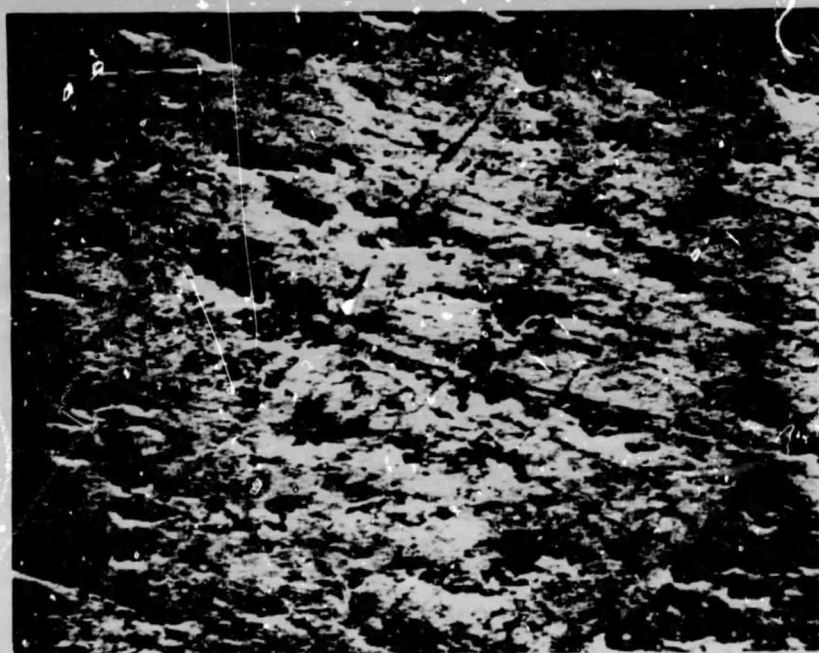
FIGURE 3. SCANNING ELECTRON MICROGRAPHS OF WORN  
AREAS OF OUTER RACE OF BEARING  
8517903

The outer race of bearing 8517903 also had continuous distinct bands of wear and pitting resulting from contact with the balls. Mild wear, generally not entirely through the original grinding scratches, extended from 10 mm (0.040 inch) from the thrust-side chamfer with a width of 3.12 mm (0.123 inch). The edge of the mild-wear track away from the chamfer was defined by a continuous row of pits with depths of approximately 0.013 mm (0.0005 inch). Alongside the row of pits was a worn band 1.1 mm (0.042 inch) in width consisting of mild wear and fine pitting. Finally, a smooth, polished band 0.64 mm (0.025 inch) in width completed the total area of ball contact. All of the bands were continuous in width and location around the race, which indicates that no significant non-synchronous (stationary) radial load was experienced during running.

SEM micrographs of the outer race wear areas are shown in Figure 3. The pitting in Figure 3(a) was a combination of straight-sided pits (probably lobalized fatigue pits) and shallow rounded pits (probably caused by indentation by the debris from the fatigue pits). The pitting in the mildly worn band, Figure 3(b), was similar to that in the heavily pitted band of Figure 3(a), except that the concentration of pits was much lower. Also, the areas between the pits were smooth and polished, which gave the appearance in optical microscopy of this band having had much milder wear.

(a) Heavily Pitted Band

(b) Mild Wear Band

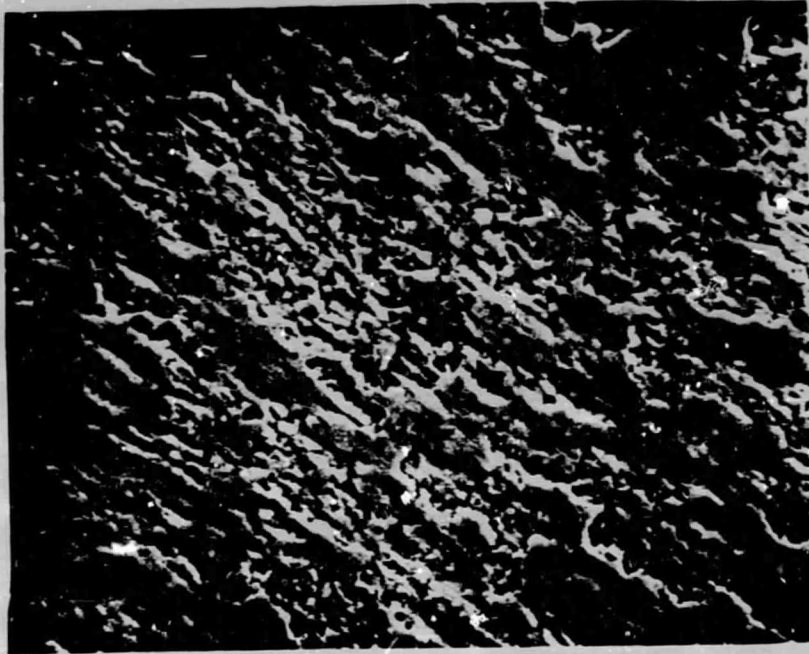
FIGURE 4. SURFACE OF BALL FROM BEARING 8517903  
SHOWING WEAR IN BAND AREA

Examination of the balls by SEM found the worn bands to have the appearance shown in the micrograph in Figure 4. The wear probably occurred by an adhesive mechanism combined with some pitting. Subsequent running over the area then flattened the raised portions, which resulted in the raised featureless areas in Figure 4. Areas between the bands were very mildly worn with remnants of original finishing scratches still present.

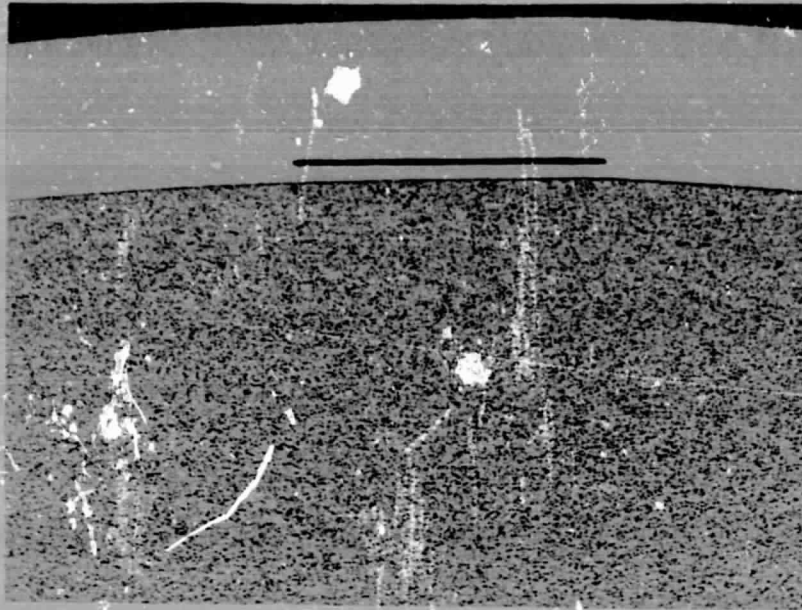
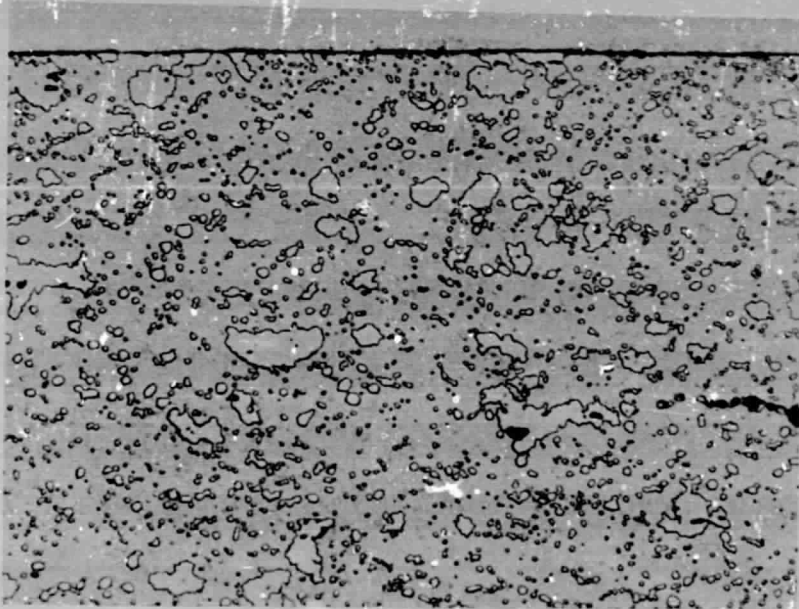
FIGURE 5. METALLOGRAPHIC CROSS SECTIONS OF BAND AREA  
ON BALL FROM BEARING 8517903

Metallographic sections were made through the balls to examine the microstructure under the bands. At lower magnifications, Figure 5(a), the bands were seen to have nearly flat areas worn on the overall ball curvature. The straight reference line was placed in Figure 5(a) above the flat region, to demonstrate its length and distinct change from the normal ball curvature. At higher magnifications, Figure 5(b), the microstructure was seen to be unchanged from normal near the surface as a result of the band formation. Microhardness readings also confirmed that the steel had not been tempered as a result of local overheating when the band was formed.

(a) Flat worn area of band

(b) Microstructure under Band

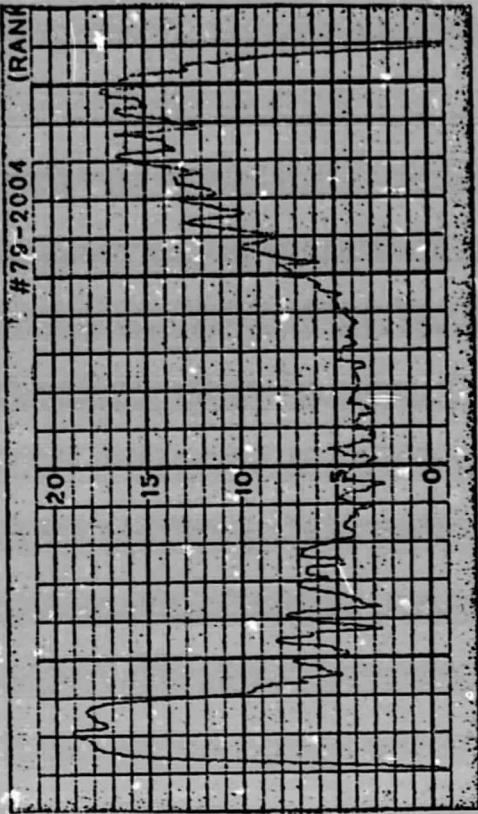
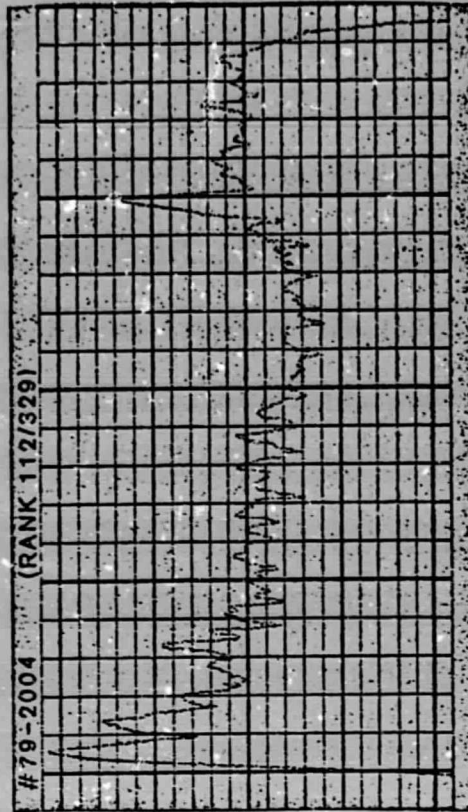
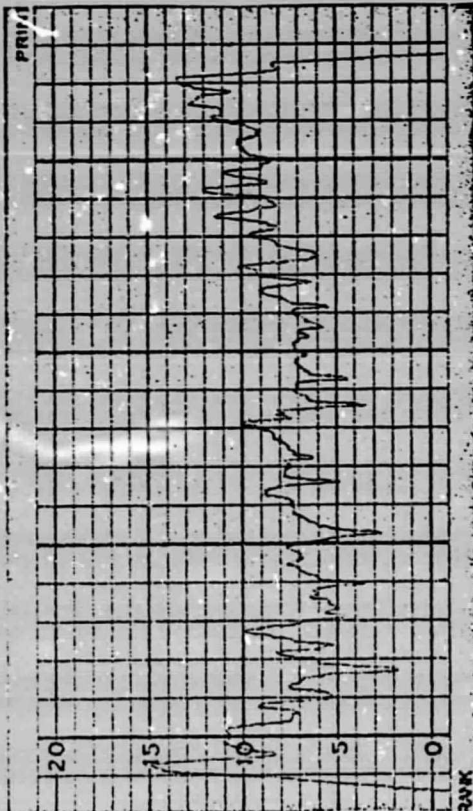
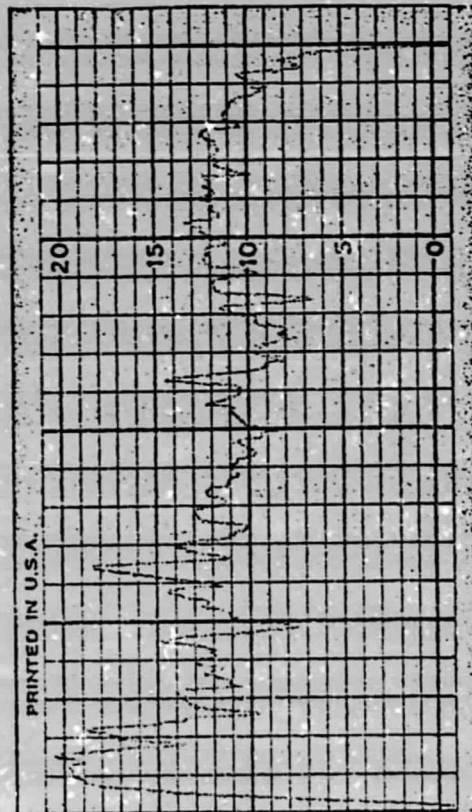
FIGURE 6. PROFILES OF WEAR AREAS OF RETAINER BALL POCKETS FROM BEARING 8517903  
MAGNIFICATIONS, MINOR DIVISIONS,  
VERTICAL : 5.0  $\mu$ m (200 microinches)  
HORIZONTAL: 0.25 mm (.010 inch)

Talysurf profiles were taken across the ball pockets to measure the depth of wear from contacting the balls. Representative traces are shown in Figure 6. The lip at the outer diameter can be clearly seen as the raised portion at the left of the traces. The maximum wear depth was found to be approximately 0.025 mm (0.001 inch) which is quite tolerable.

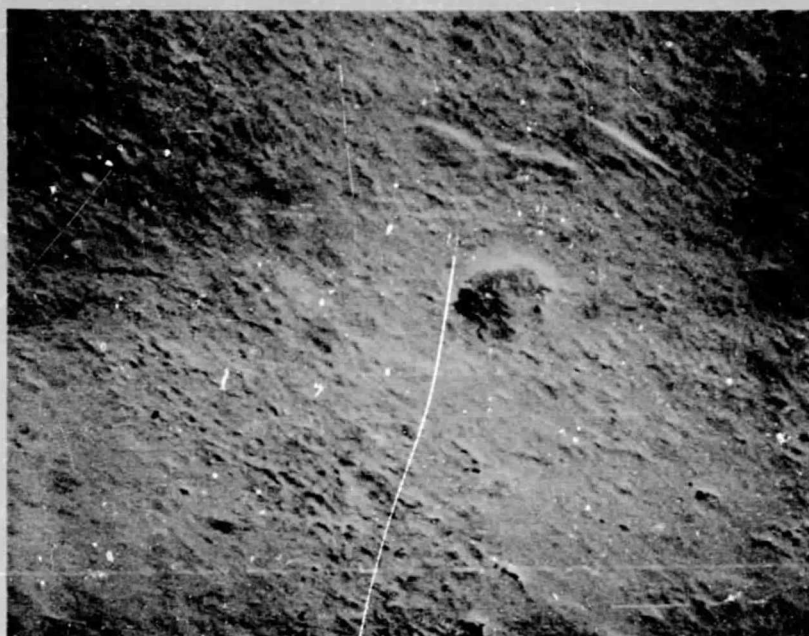
FIGURE 7. BALL CONTACT PATH ON OUTER RACE  
OF BEARING 8517900

The outer race of bearing 8517900 was also mildly worn in a ball contact path that did not vary in width or location. It had one edge located approximately 2.8 mm (0.110 inch) from the edge of the chamfer on the thrust side with a width of approximately 3.6 mm (0.140 inch). Similar to its mating inner race, remnants of original grinding scratches were present in much of the ball contact path, which is associated with mild wear. Scattered soft debris dents were also present on the outer race ball-contact track. An SEM micrograph of an area in the ball contact path is shown in Figure 7. The surfaces consist mostly of very fine pits with scattered larger pits, which may have resulted from debris.

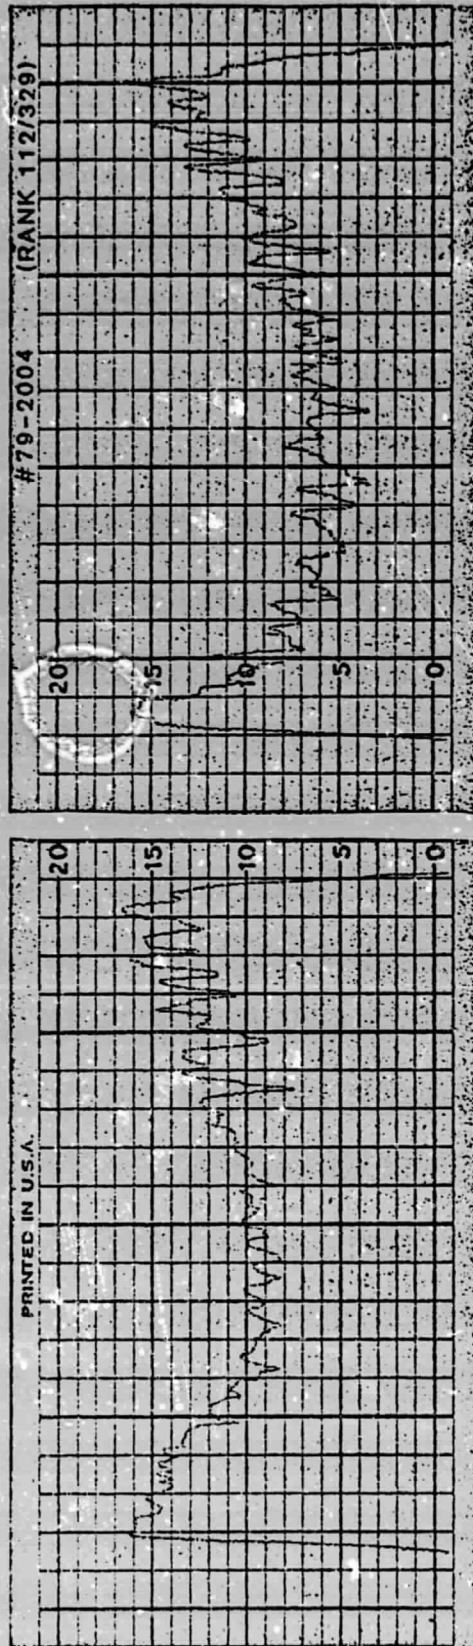
FIGURE 8. PROFILES OF WEAR AREAS IN BALL POCKETS OF RETAINER FROM BEARING 8517900  
 MAGNIFICATIONS, MINOR DIVISIONS,  
 VERTICAL : 5  $\mu$ m (200 microinches)  
 HORIZONTAL: 0.25 mm (0.010 inch)

The retainer from bearing 8517900 was in excellent condition and had only minor wear areas in the ball pockets. There was no evidence of distress as a result of service. Stylus profilometer traces across the ball pocket wear areas are shown in Figure 8. A raised lip was also present at the outer diameter surface of the ball pocket of this retainer, which can be seen at the left of Figure 8. The wear depth appeared to be a maximum of less than 0.025 mm (0.001 inch).

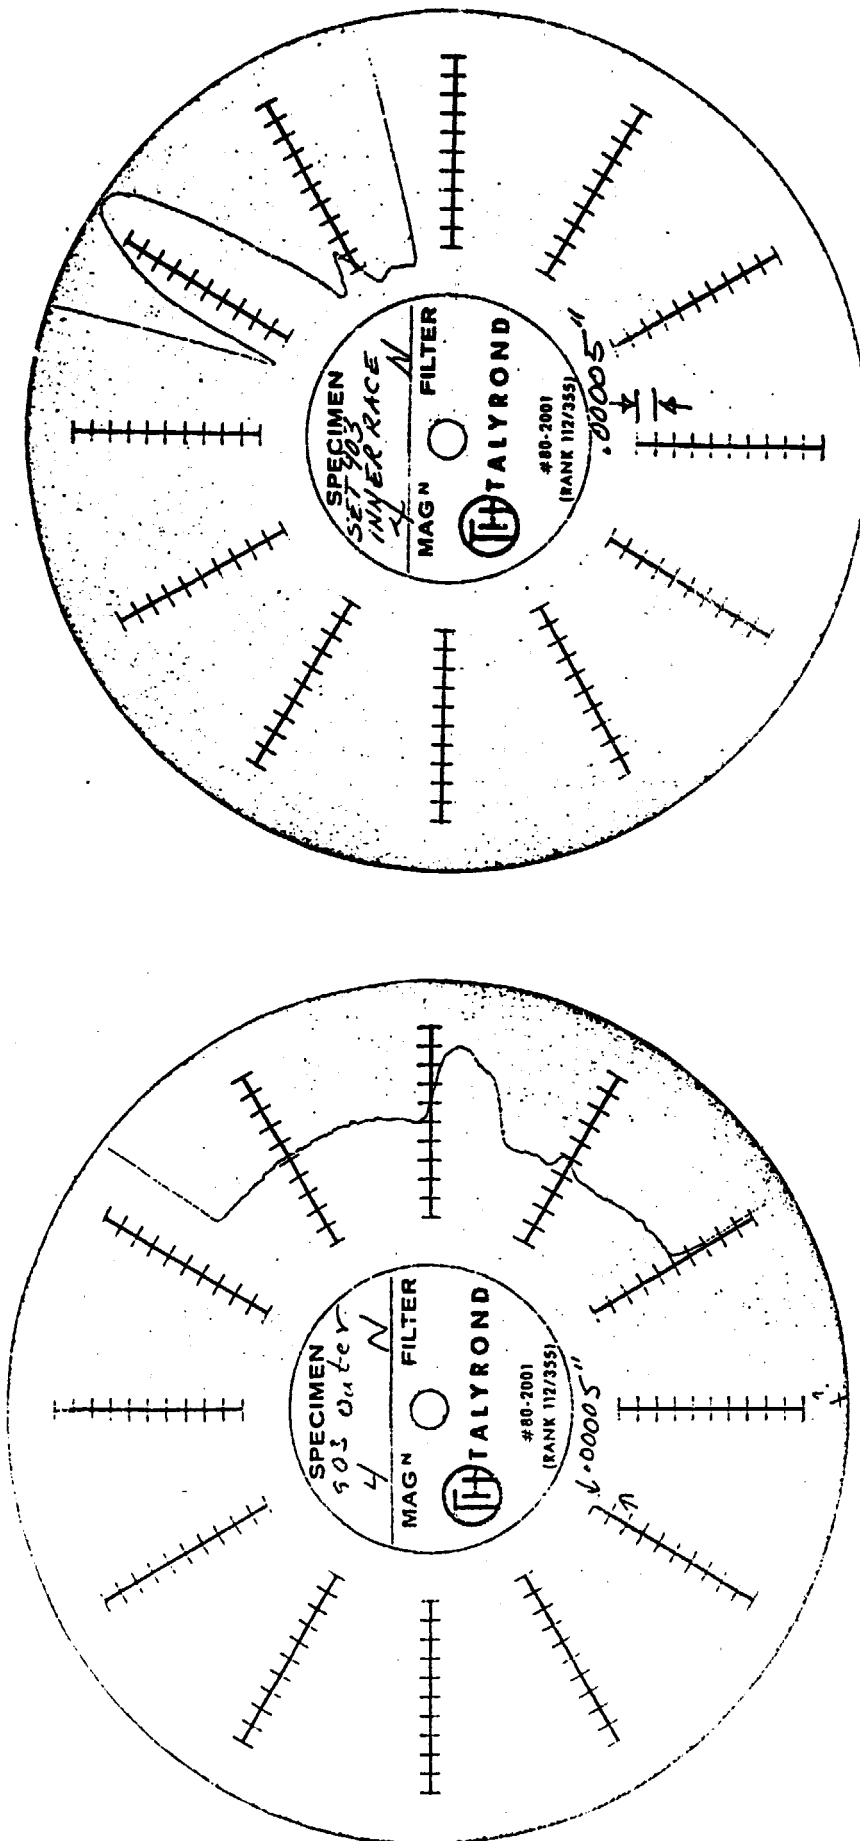
FIGURE 9. CROSS-RACE CURVATURES OF RACES FROM BEARING 8517903  
 RADIAL MAGNIFICATION,  
 1 Division = 1.27  $\mu$ m (50 microinches)

Shown in Figure 9 are the traces attained on the races from bearing 8517903. The outer race, Figure 9(a), showed a groove approximately 5  $\mu$ m (200 microinches) in depth near the center of the race. Since the area of the groove appeared to be completely unworn by microscopic examinations, the groove probably was produced by the original manufacturing. However, the groove measuring 1.27  $\mu$ m (50 microinches) deep corresponded to the wear track area. The area of heavy race wear was clearly visible on the profile of the inner race, Figure 9(b). A maximum wear depth of approximately 15  $\mu$ m (600 microinches) was measured in the region that conformed to the curvature of the ball.

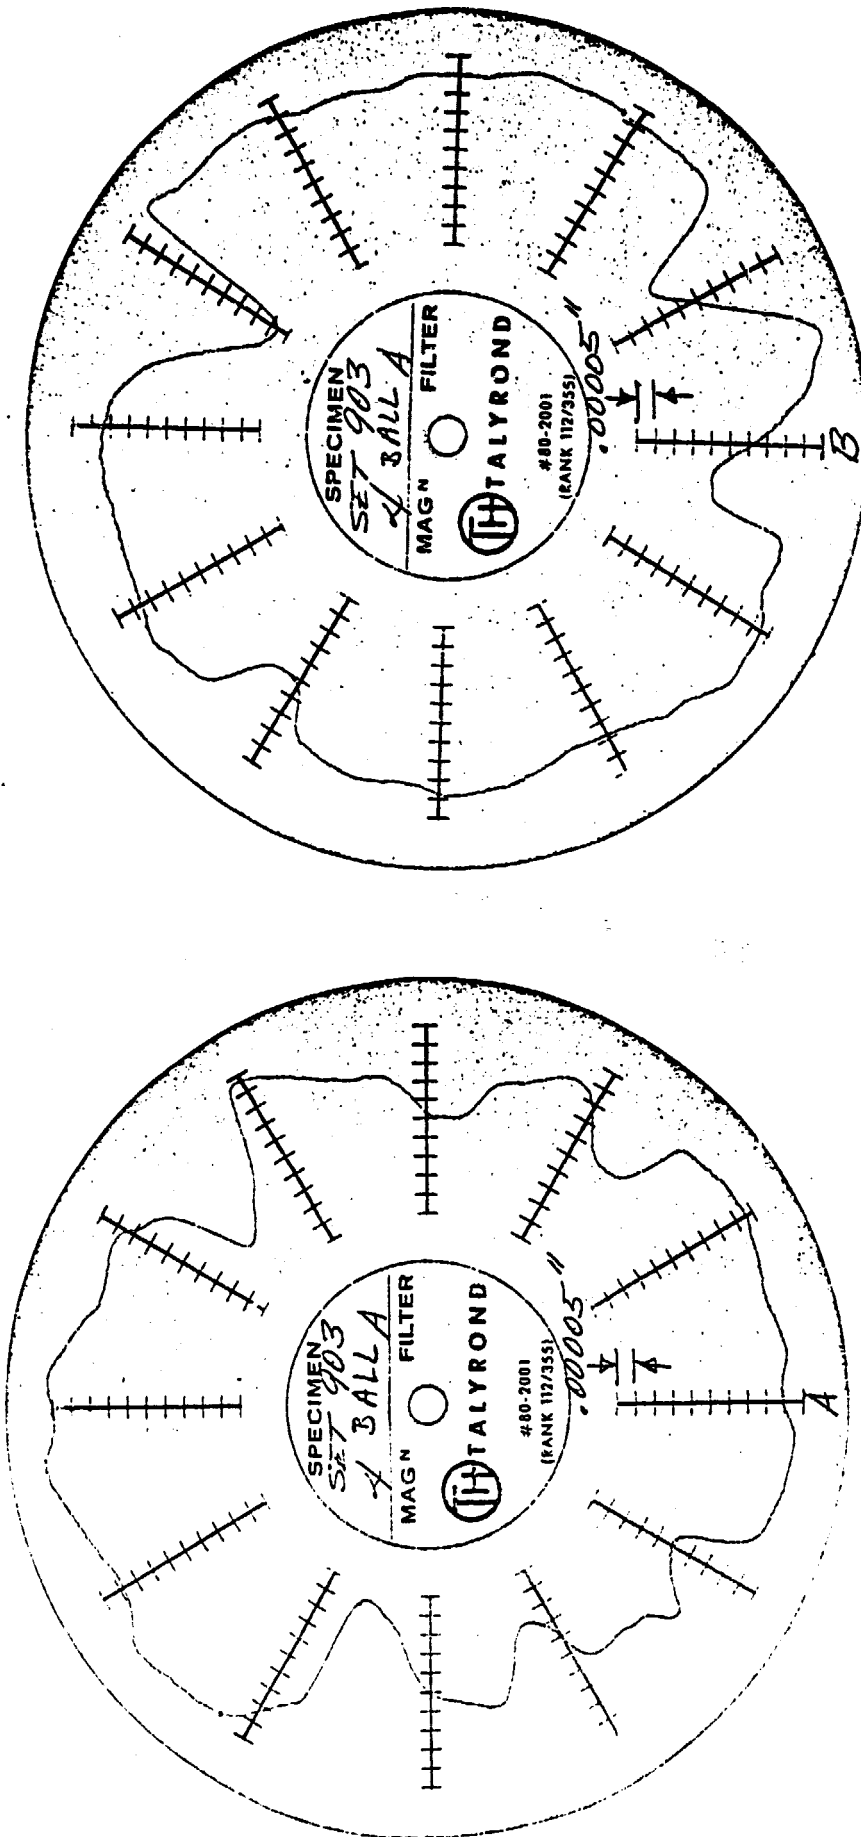
FIGURE 10. ROUNDNESS MEASUREMENTS ON TWO BALLS FROM BEARING 8517903  
 RADIAL MAGNIFICATION,  
 1 Division = 1.27  $\mu\text{m}$  (50 microinches)

Talyrond traces of two balls from bearing 8517903 are shown in Figure 10. The depth of the wear bands below the original curvature is clearly visible. A maximum depth of approximately 11  $\mu$ m (450 microinches) was measured. Since the Talyrond magnification is very high radially, the shape of the wear bands is greatly distorted. The actual shape was shown to be more nearly flat areas in the metallographic cross sections. Measurements of

the angular locations of the bands showed the average included angle of the cone formed by mid-position of the bands and the center of the ball was approximately 125 degrees. The average angular width of the bands was 25 degrees. The bands represent a major deterioration of the original geometry of the balls.

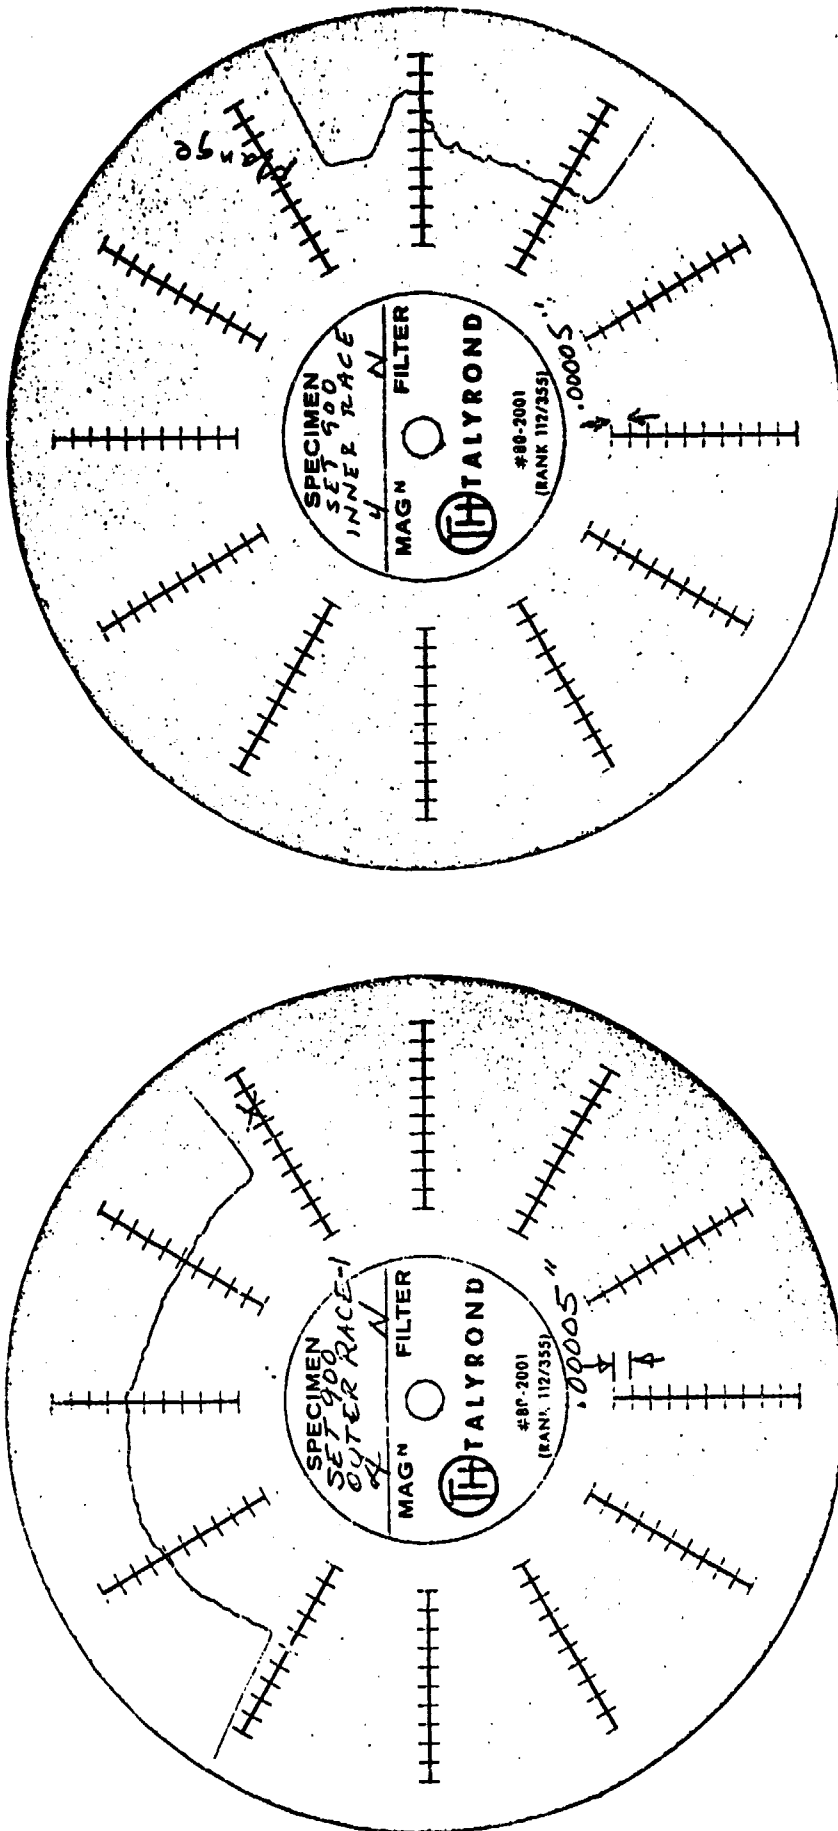
FIGURE 11. CROSS-RACE CURVATURES OF RACES FROM BEARING 8517900  
 RADIAL MAGNIFICATION,  
 1 Division = 1.27  $\mu$ m (50 microinches)

Cross-race curvature measurements made on the races from bearing 8517900 are shown in Figure 11. The slight deviation from roundness on the outer race, Figure 11(a), may have been produced during manufacturing. The groove seen in Figure 11(b) on the inner races was approximately 3.8  $\mu\text{m}$  (150 microinches) below the normal curvature. Since this occurred in the ball track area, it probably was caused by wear from the balls.

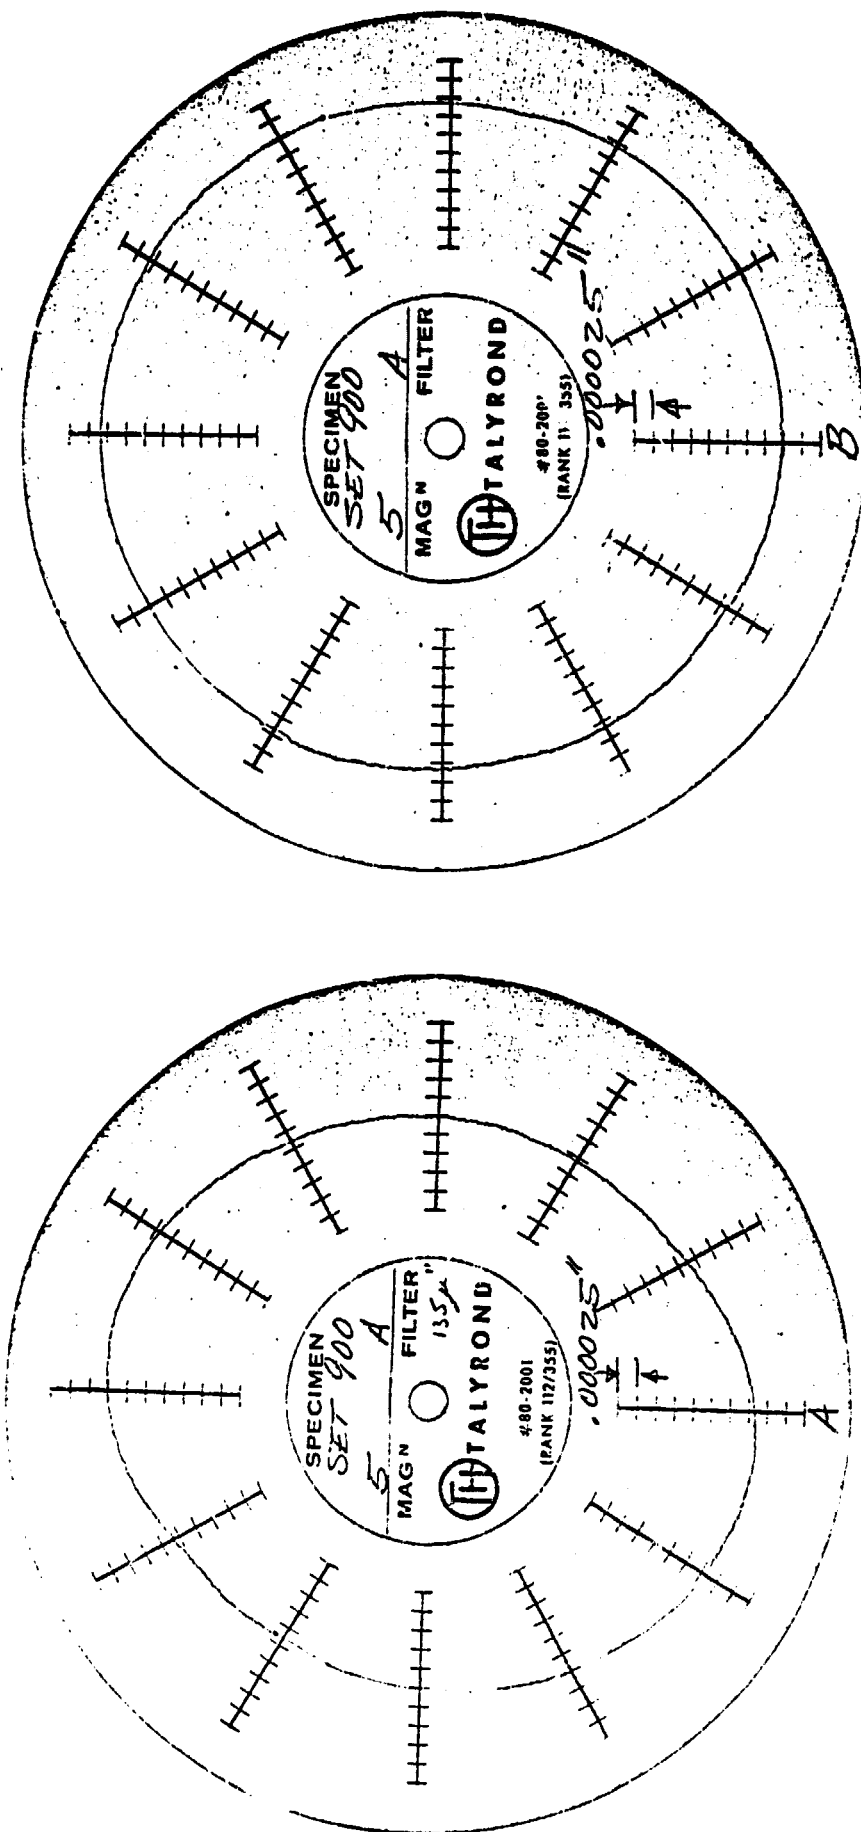
FIGURE 12. ROUNDNESS MEASUREMENTS ON TWO BALLS FROM BEARING 8517900  
 RADIAL MAGNIFICATION,  
 1 Division = 0.64  $\mu\text{m}$  (25 microinches)

The roundness traces attained on two balls from bearing 8517900 are shown in Figure 12. The difference between the maximum and minimum diameters of the ball in the upper trace was approximately 3.4  $\mu\text{m}$  (135 microinches). Since these balls were very mildly worn in local bands only (whose planes were oriented perpendicular to the plane of the chart), this out-of-roundness was probably present from manufacturing. This deviation is well out of tolerance for balls used in precision bearings. The second ball, in the lower chart, showed a deviation from roundness of approximately 0.64  $\mu\text{m}$  (25 microinches), which is much more acceptable.

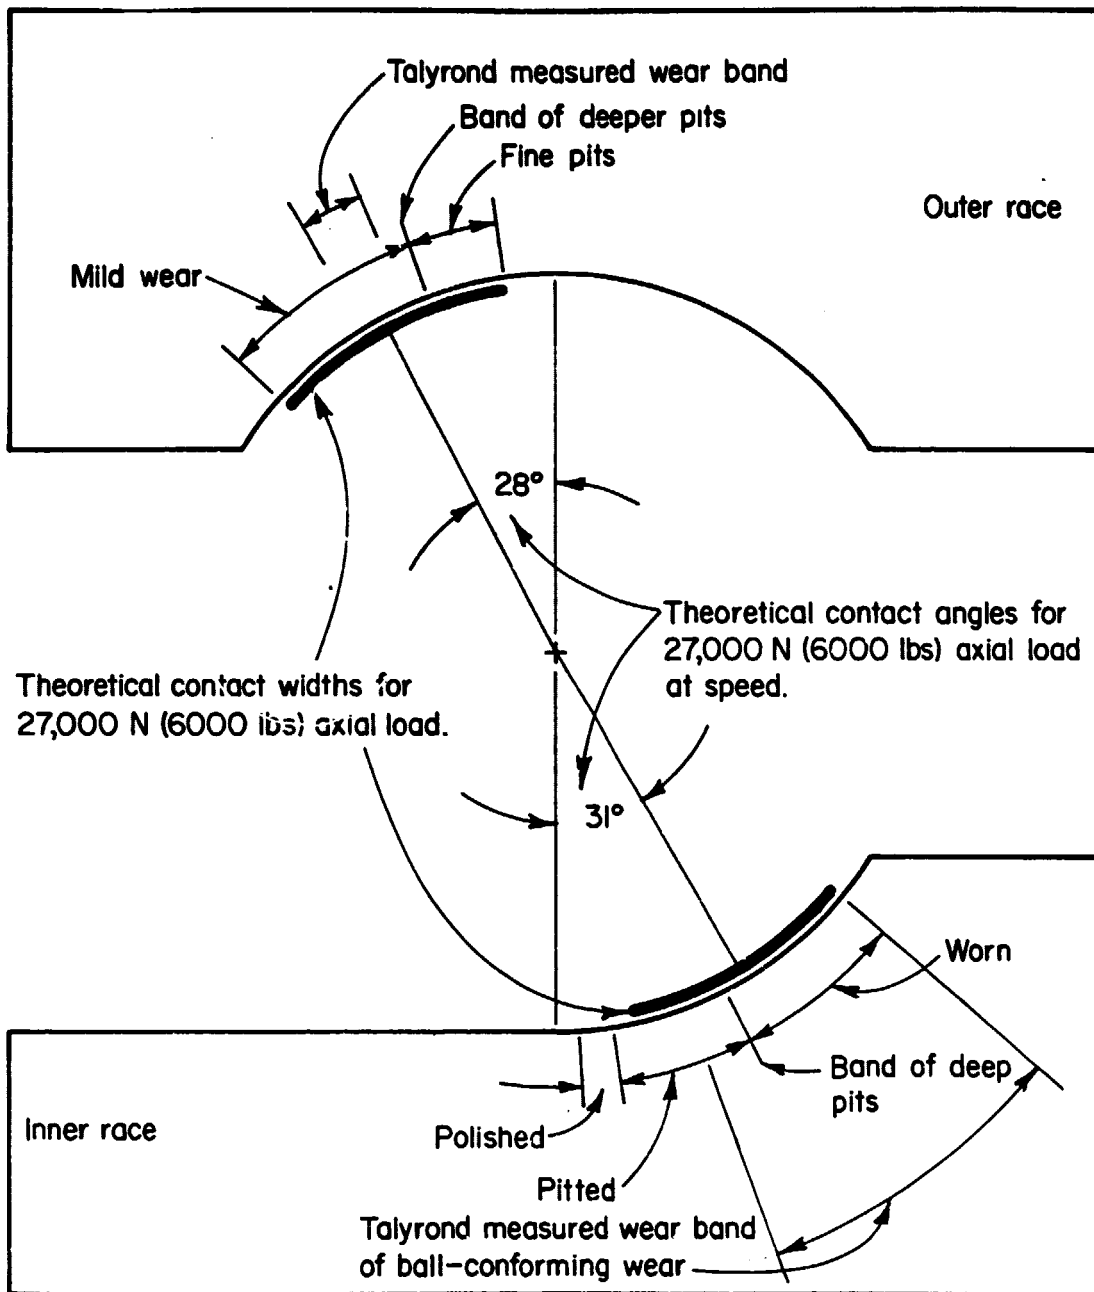
FIGURE 17. COMPARISON OF LOCATION OF ACTUAL BALL CONTACT LOCATIONS WITH THEORETICAL PREDICTIONS ON BEARING 8517903

In Figure 17, the locations of the predicted ball contact paths are seen to coincide quite well with the measured locations for axial load of approximately 27,000 N (6000 pounds). The small-circle banding of the balls probably resulted from contact with the chamfer on the inner race, which corresponded fairly well to the average location of the bands (not shown in Figure 17).

The results of these measurements and calculations show that the bearing pair had a strong axial load applied against the 8517903 inner race, which was resisted by the outer race of that bearing. Since the outer race is designed to be able to respond to axial loads, by moving axially, either the outer race was restricted from doing so because of mechanical interference or the total limit of travel was reached.

- (1) Make the assembly or design modifications required to insure that no high axial load levels are applied to the bearings. The high load experienced by bearing 8517903 must have resulted from an outer race lock-up or operation at the extreme limits of axial travel. Both possibilities should be explored to identify the cause.

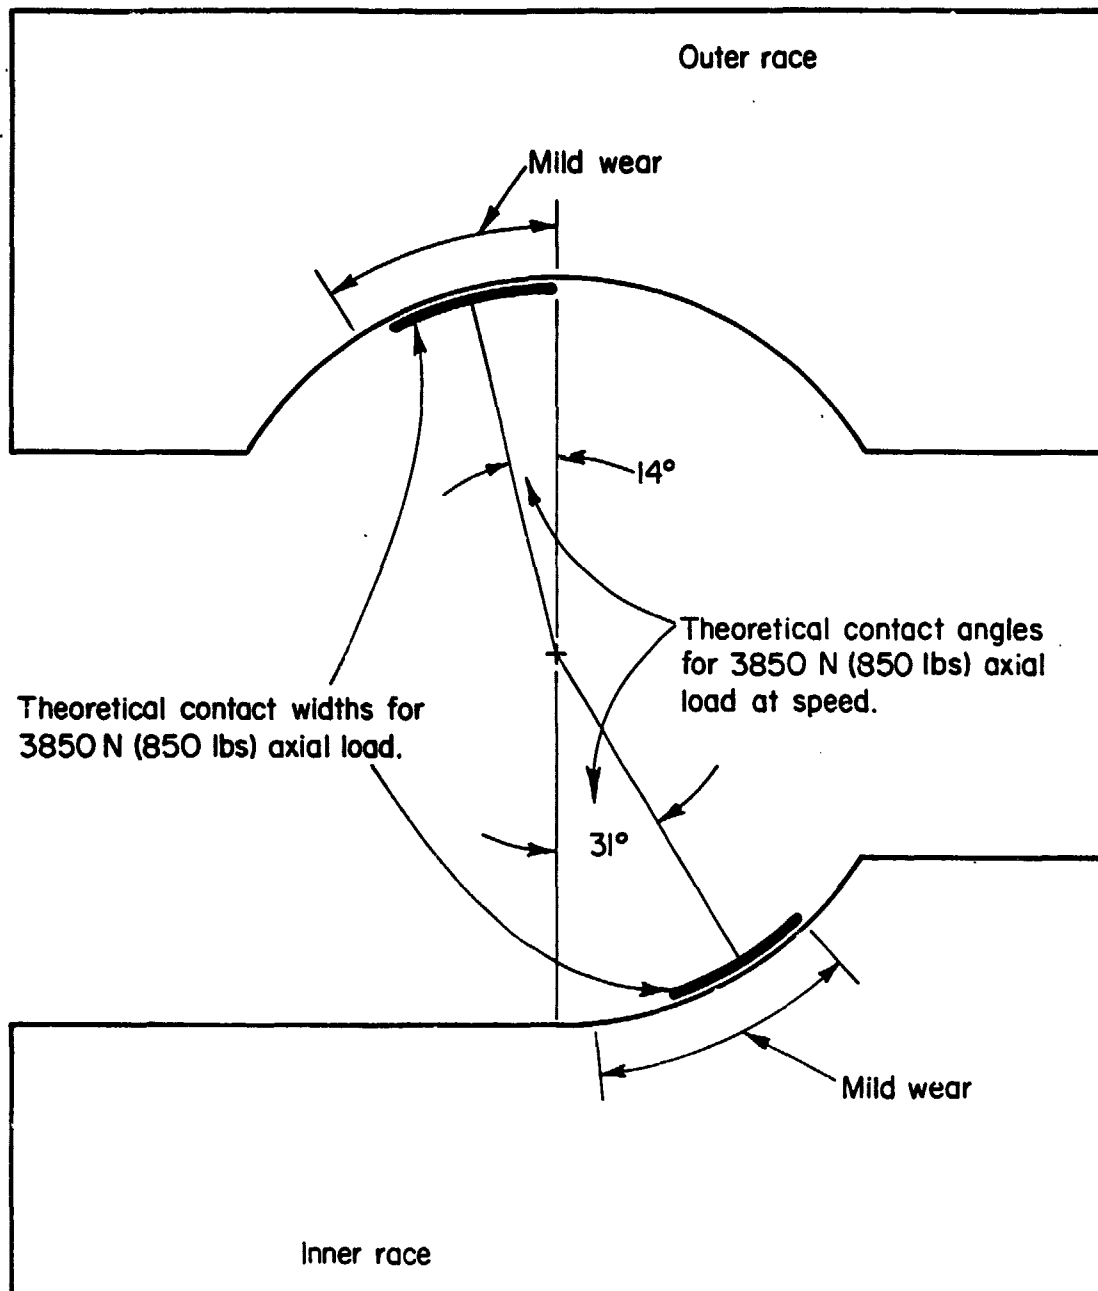
FIGURE 18. COMPARISON OF LOCATION OF ACTUAL BALL CONTACT LOCATIONS WITH THEORETICAL PREDICTIONS ON BEARING 8517900

In Figure 18, the wear patterns on bearing 8517900 indicate that the normal axial preload of 3,800 N (850 pounds) was probably not exceeded for any significant period of time during operation of this bearing. The wider contact areas on both races resulted from start-up operation when the contact angle operates near the 20-degree design angle. As the bearing reaches operating speed, the contact angles change to those shown in Figure 18, thus explaining the wider wear areas, especially on the inner race.
